New York State Department of Transportation

Yellow Flag NB2222W009

BIN: 1065318
Feature Carried: 278I278IX2M23027
Feature Crossed: 6TH AVENUE
Orientation: 8 - NORTHWEST
Region: 11 - NEW YORK CITY
County: KINGS
Political Unit: City of NEW YORK
Approximate Year Built: 1962
Posted Load Matches Inventory : Yes
Bridge Load Posting (Tons) : Not Posted for Load
Primary Owner: New York State Department of Transportation
Primary Maintenance Responsibility: 12 - State - Subcontracted to another Party
Typical or Main Span Type: 3 - Steel, 02 - Stringer/Multi-Beam or Girder
This Bridge is not a Ramp
Number of Spans: 322

Location: Span 254, Girder G1 at Pier 254

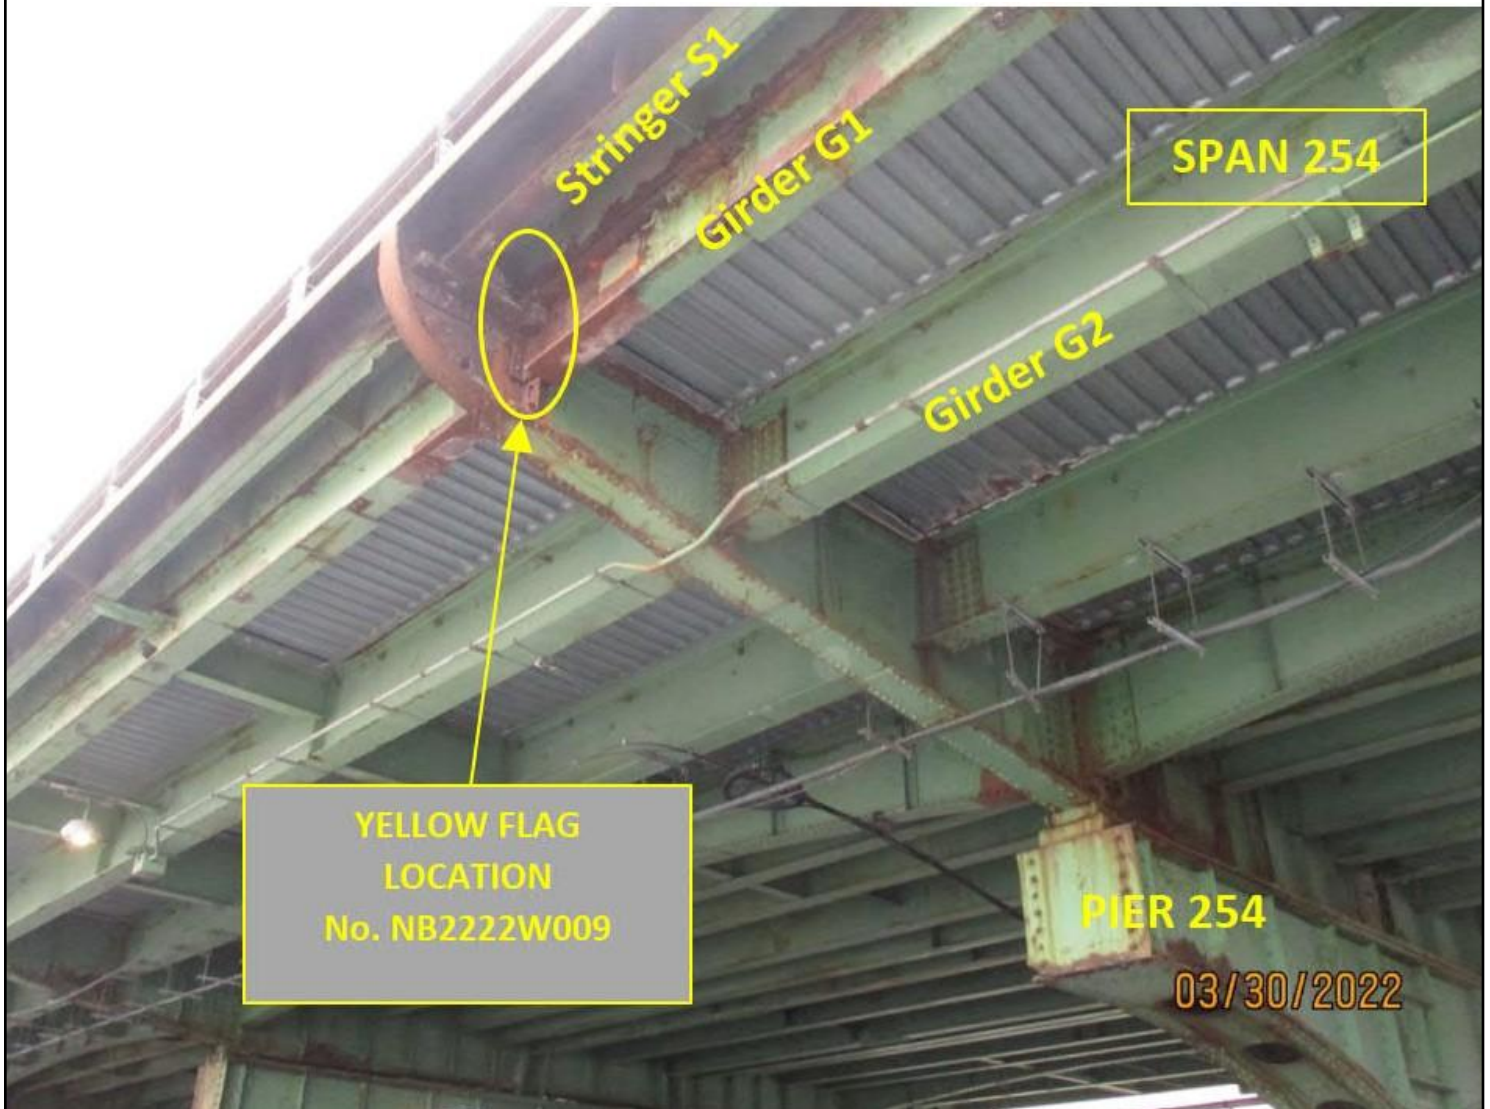
Photo Number: 1

Attachment Description: Photo 4673 – Span 254, Girder G1 at Pier 254. General view of the flagged location at pier cap connection. Looking end right.

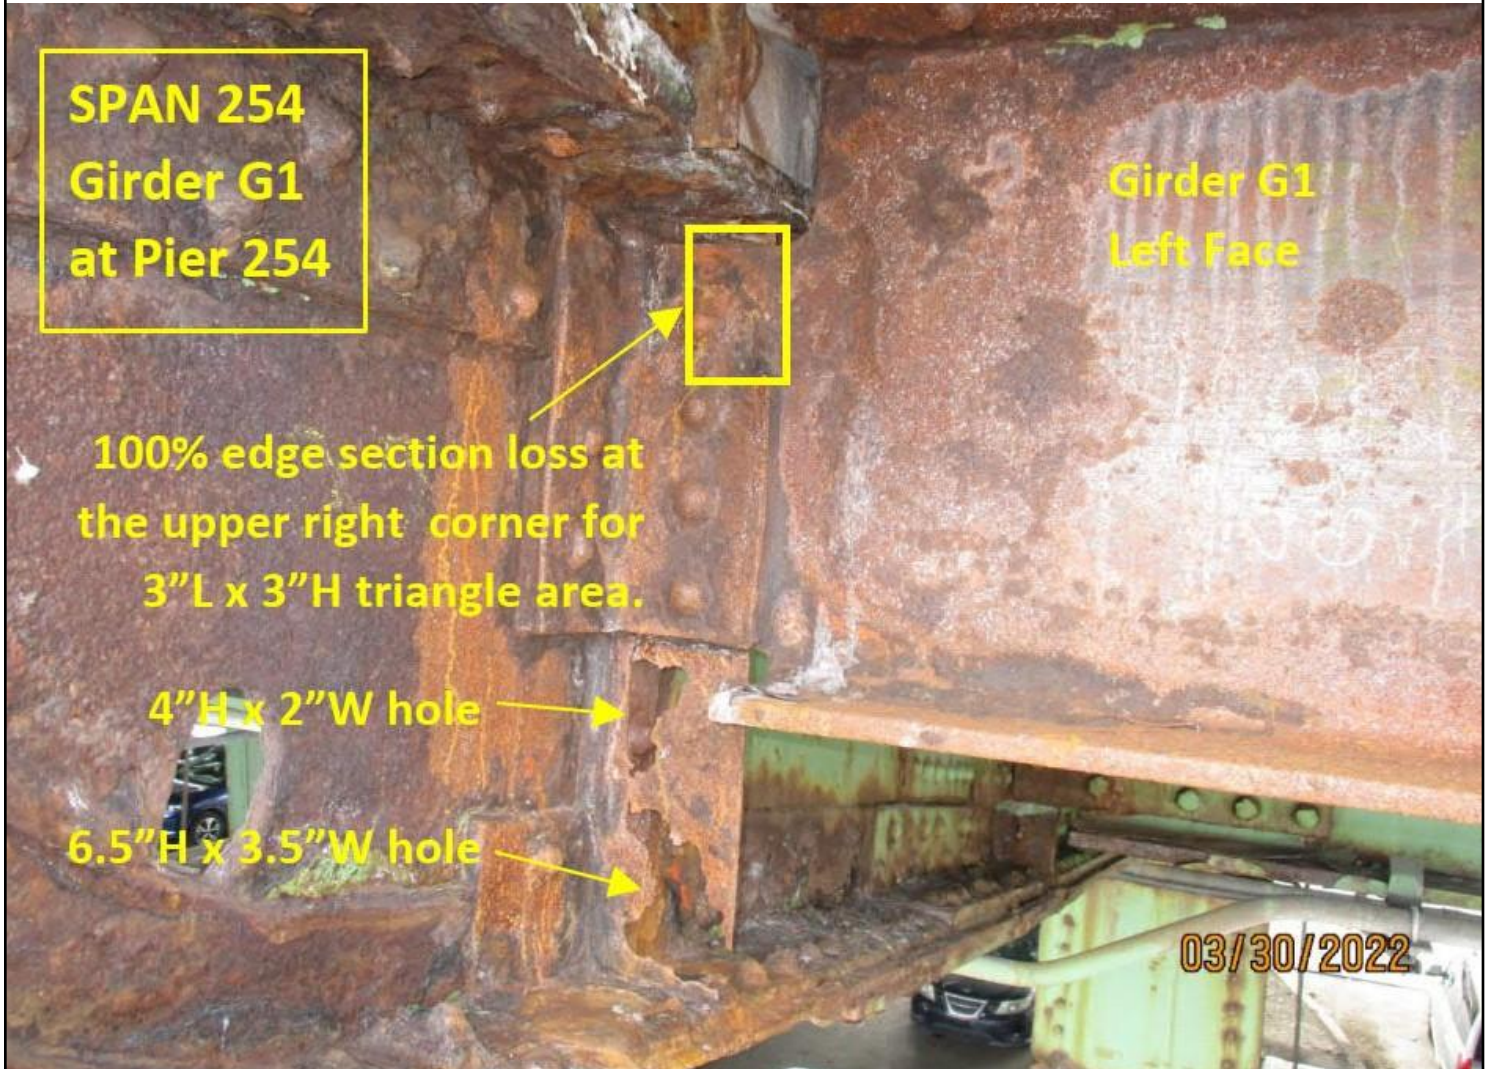
Photo Number: 2

Description: Girder G1 web along connection angle exhibits overall 51% section loss for full height (previously noted to be 53%).

3.The right connection angle exhibits two corrosion holes at measuring 4"H x 2"W and 6.5"H x 3.5"W (previously noted to be 1.25"L x 3.25"H and 3"L x 5"H). The remaining height of the connection angle below Girder G1 exhibits up to 90% section loss (no change). The right connection angle along the web of Girder G1 is in good condition with minor pack rust at the top.

Attachment Description: Photo 4676 – Span 254, Girder G1 at Pier 254. Close-up view of Girder G1 showing heavy section loss to the web of the Girder and corrosion holes in connection angle. Looking end right.

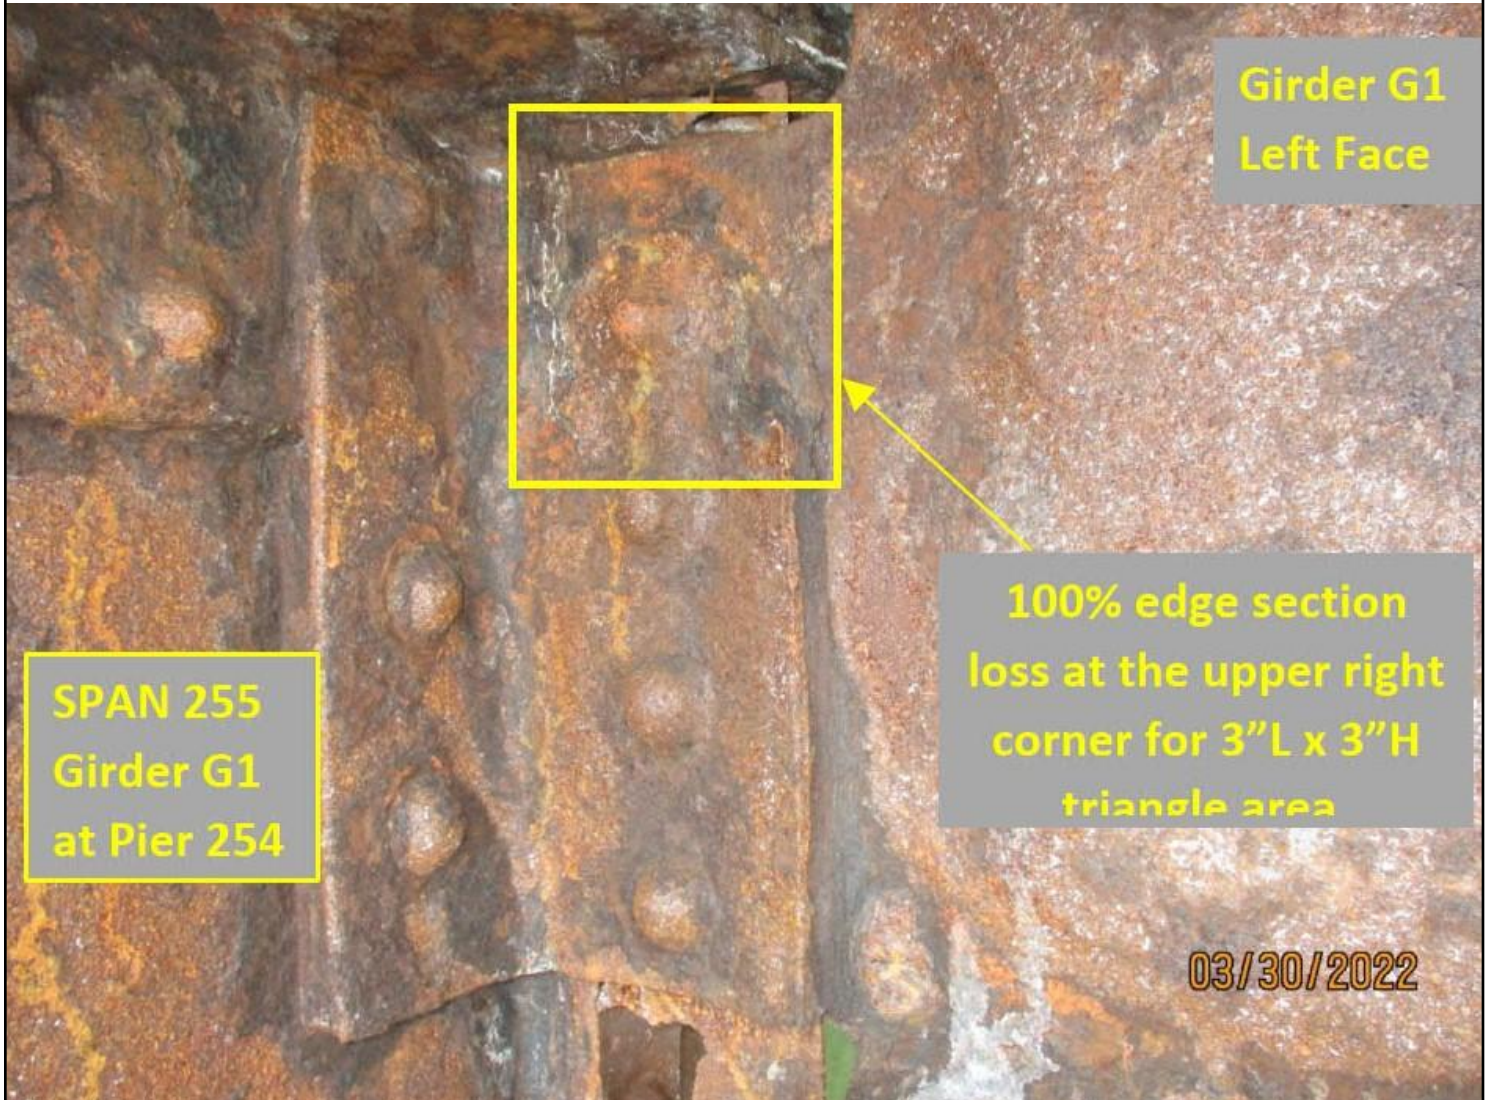
Photo Number: 3

2.The left connection angle exhibits up to 50% section loss along the fillet (no change from previous) and 100% edge section loss at the upper right corner for 3"L x 3"H triangle area (previously noted to be 1"L x 3"H).

Attachment Description: Photo 4678 – Span 254, Girder G1 at Pier 254. Close-up view of 100% edge section loss at the upper right corner for 3"L x 3"H triangle area. Looking end right.

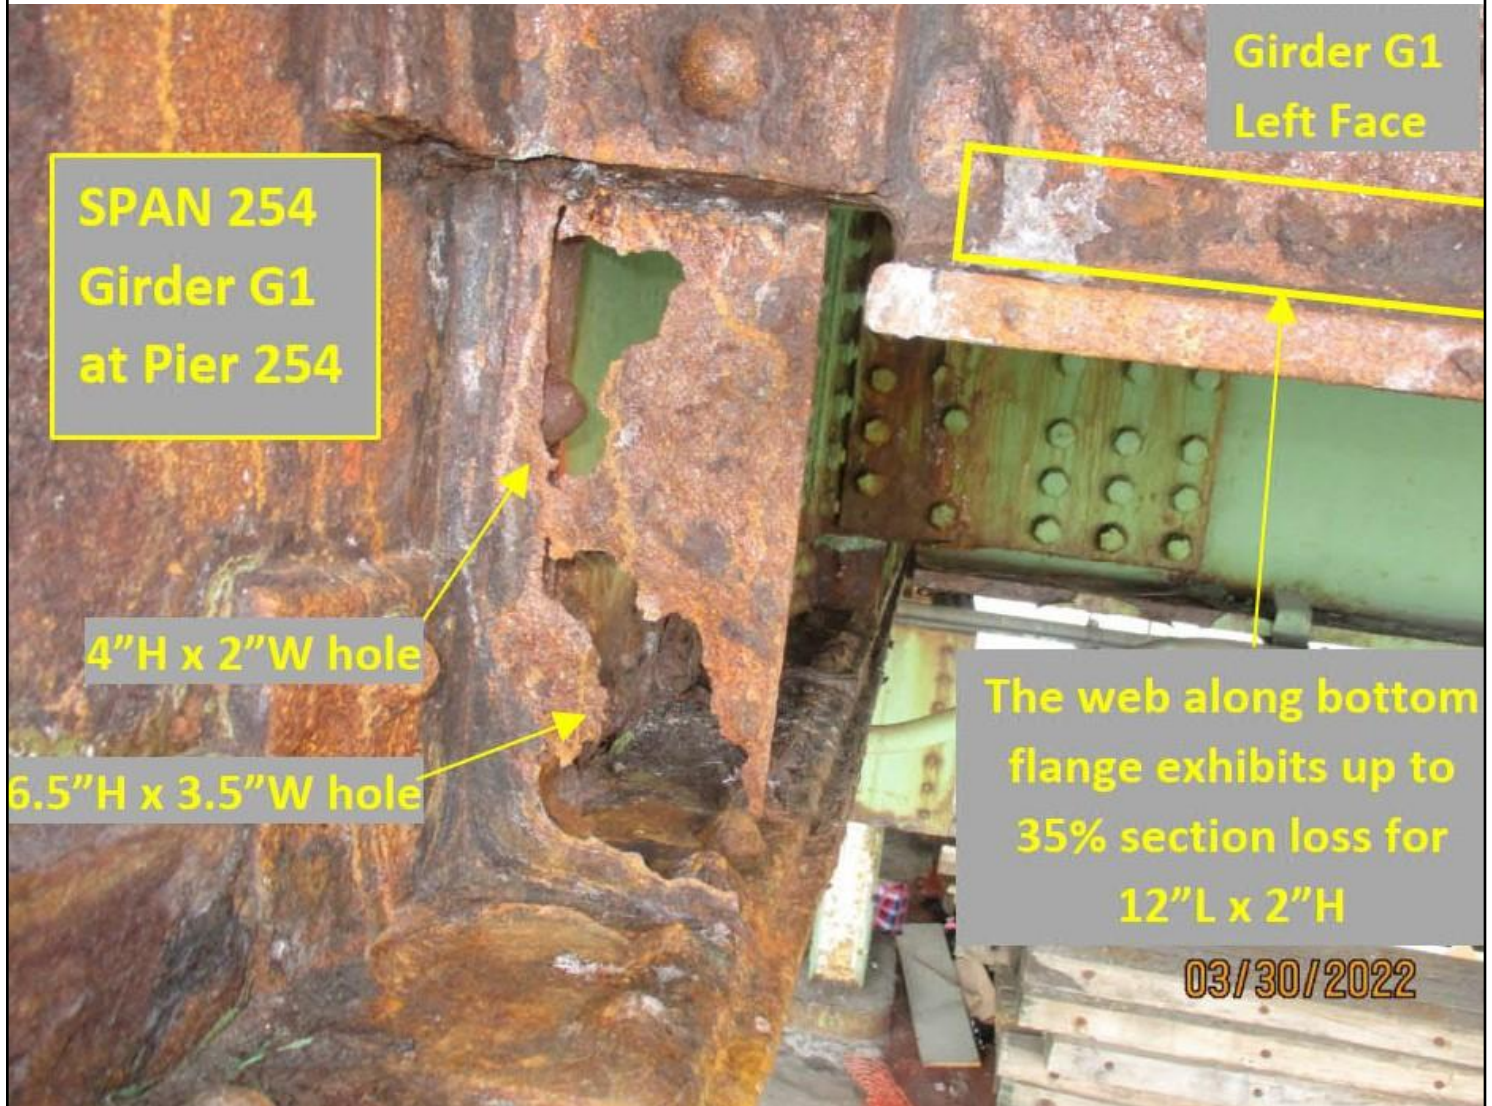
Photo Number: 4

4.Girder G1 web along bottom flange exhibits up to 35% section loss for 12"L x 2"H area (no change).

Attachment Description: Photo 4658 – Span 254, Girder G1 at Pier 254. Close-up view of the right connection angle that exhibits two corrosion holes measuring 4\"L x 2\"H and 3.5\"W x 6.5\"H. In addition, the web along bottom flange exhibits up to 35% section loss for 12\"L x 2\"H area. Looking right.

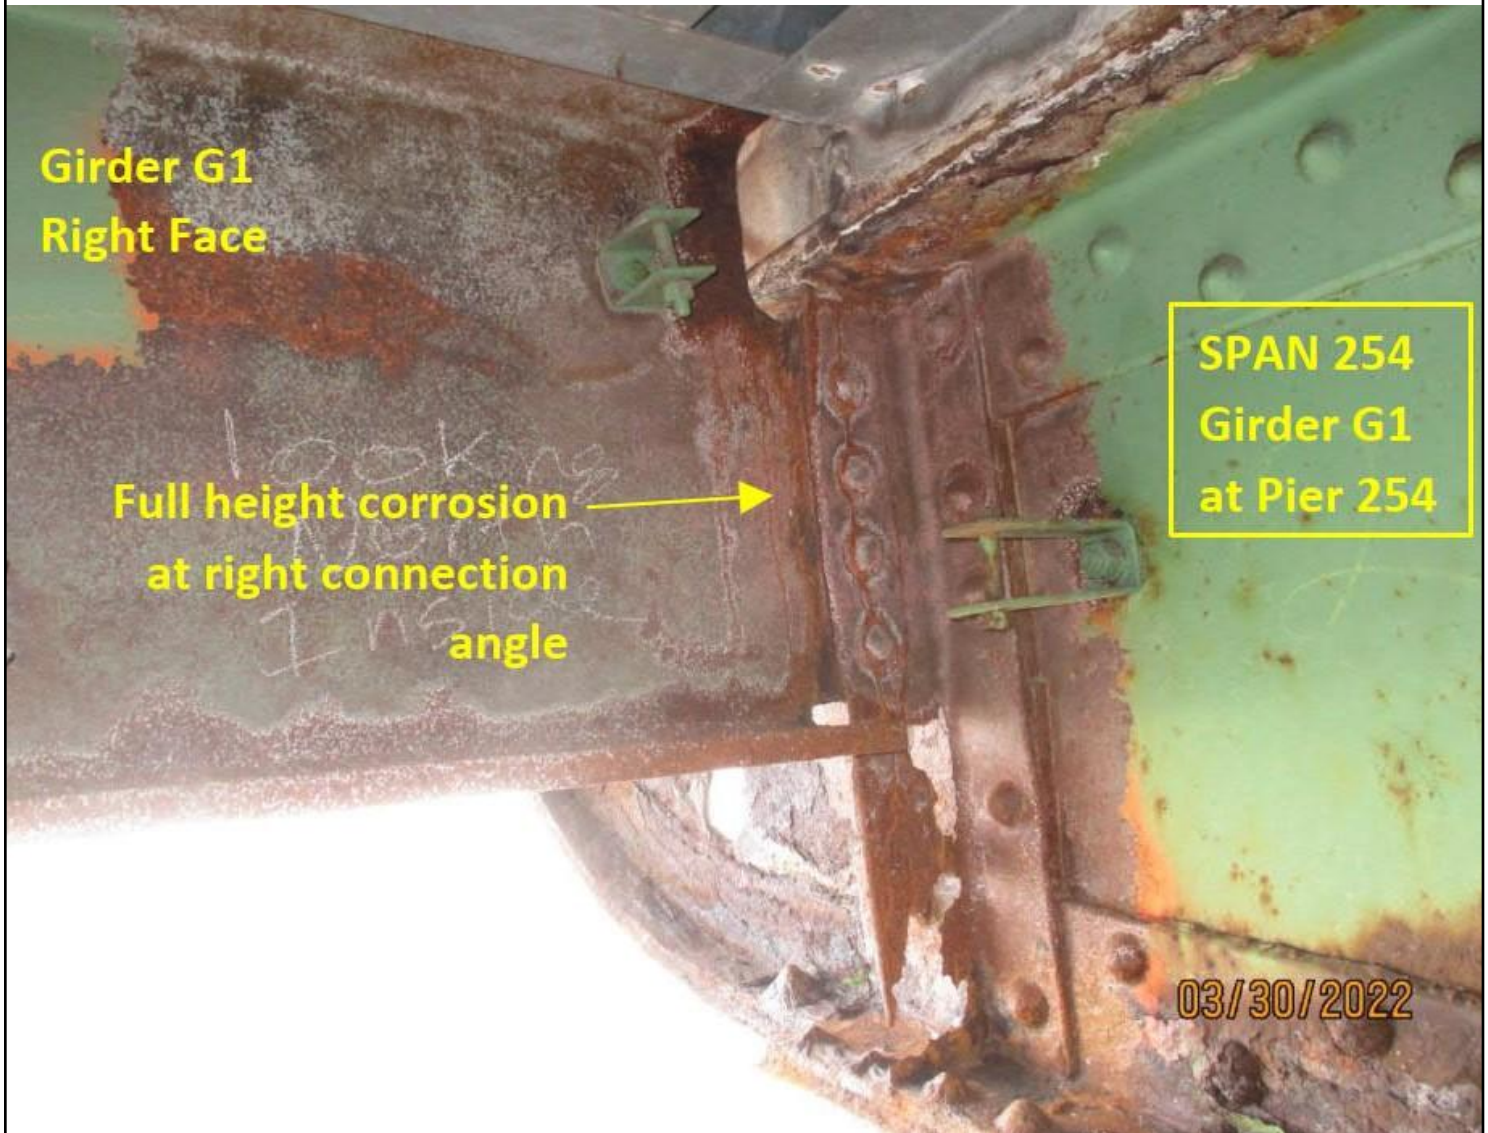
Photo Number: 5

Attachment Description: Photo 4683 – Span 254, Girder G1 at Pier 254. General view of Girder G1 right side web and connection angle. The web exhibits full height section loss. Looking end left.

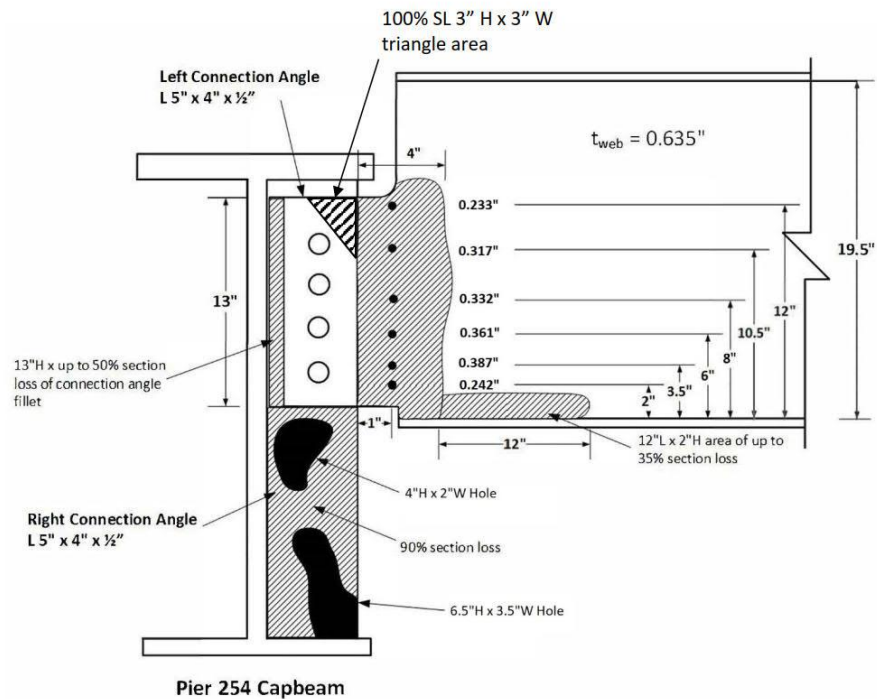
**Span 254, Girder G1 at Pier 254
 (Looking Right)
 N.T.S**

Average remaining web section – $((0.233 \times 2.5) + (0.317 \times 2.5) + (0.332 \times 2) + (0.361 \times 2.5) + (0.387 \times 1.5) + (0.242 \times 2))/6 = 4.008$ sq. in.
 Original Section = 13" H x 0.635" T = 8.255 sq. in.
 Web section loss – $((8.255 - 4.008)/8.255) \times 100\% = 51.4\%$ **SAY = 51%**

Attachment Description: SN 254 G1 at Pier 254 Sketch

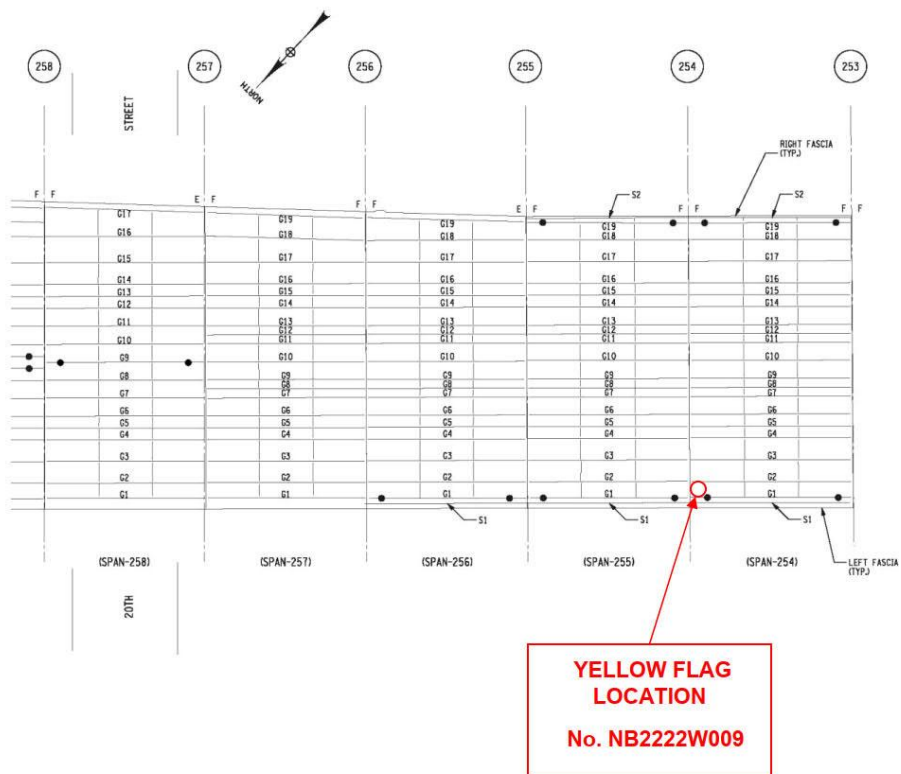
Photo Number: 7

Attachment Description: SN 254 G1 at Pier 254 Framing Plan
